Manhole Inspection Summary

Manhole # S51GG_005MH

Insp Date: **6/6/08 11:55 AM**

Location Address: **Biddle**

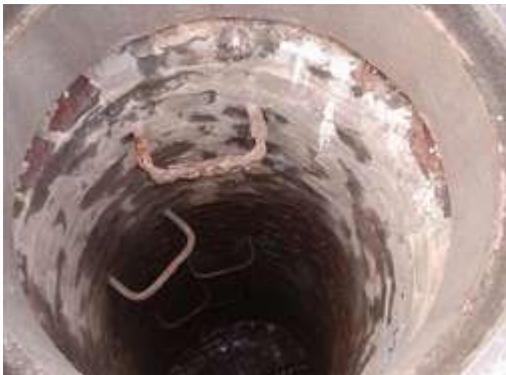
Defect 2

Infiltration: ☐ None ☒ **Joint** ☐ Cracks ☒ **Mortar** ☐ Roots ☐ Wall

infiltration

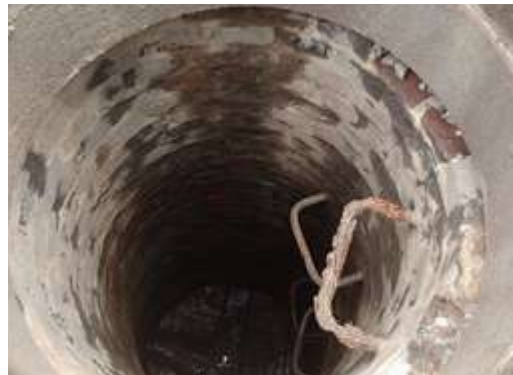
Defect 1

Condition: ☐ Sound ☐ Cracked ☐ Root Intrusion ☒ **Loose Brick** ☐ Deteriorated

loose bricks

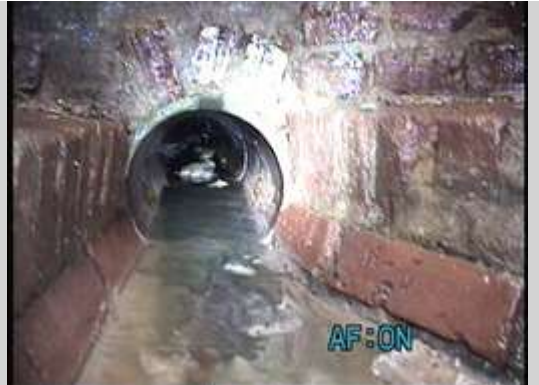
12 O'Clock Outflow

8 in. Circular Gravity Sewer
Pipe Out @ 12 O'Clock

Pipe Height: **8.4** (in.) Rod and Bar (Angled)
Pipe Material: **Clay** ☐ Pipe Lined
Invert Depth: **15.25** (ft.) Flow Characteristics: **Fast**
Deposits: ☒ None ☐ Mud ☐ Sludge ☐ Debris ☐ Grease
Silt Depth: (in.) Deposits Extent:
Infiltration: **None** Pipe Seal Cond: **Sound**

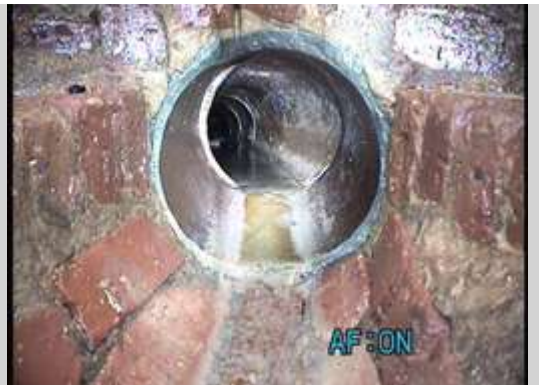
3 O'Clock Inflow

8 in. Circular Gravity Sewer
Pipe In @ 3 O'Clock

Pipe Height: **8.4** (in.) Rod and Bar (Angled)
Pipe Material: **Clay** ☐ Pipe Lined
Invert Depth: **14.95** (ft.) Flow Characteristics: **Fast**
Deposits: ☒ None ☐ Mud ☐ Sludge ☐ Debris ☐ Grease
Silt Depth: (in.) Deposits Extent:
Infiltration: **None** Pipe Seal Cond: **Sound**

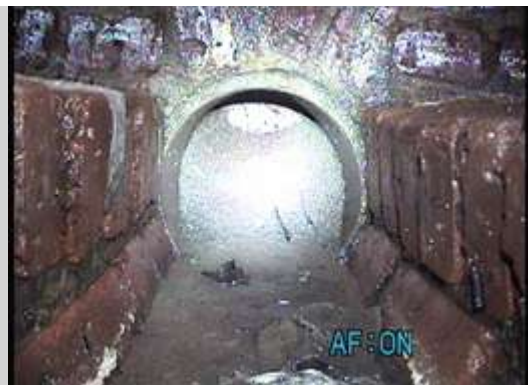
6 O'Clock Inflow

6 in. Circular Gravity Sewer
Pipe In @ 6 O'Clock

Pipe Height: **6** (in.) Rod and Bar (Angled)

Invert Depth: **14.70** (ft.) Flow Characteristics: **None**
